# **Outline Construction Environmental Management Plan**

Proposed Residential Development at Rathmullan,  
Drogheda, Co. Meath.

September 2025

**Client Name:** Earlsfort Developments Drogheda Limited  
**Document Reference:** 18-014r.401  
**Project Number:** 18-014

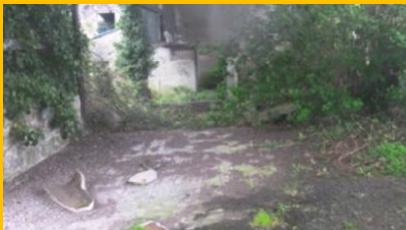
9.	Boyne ridge Rathmullan Rd	Building 2		Cement pipe debris		Chrysotile	1	3	1	1	6	Removal and disposal by a competent contractor prior to demolition. Cleanup of debris around the building.

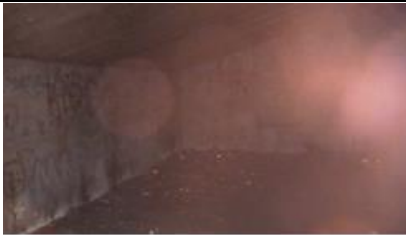
14.	Boyne ridge Rathmullan Rd	Building 2 mezzanine				NAD

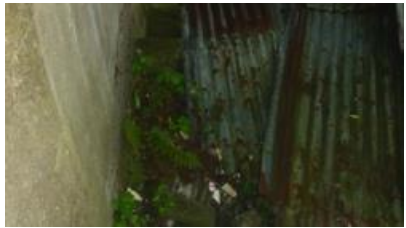
15.	Boyne ridge Rathmullan Rd	Building 2 mezzanine		Corrugated metal sheeting		NAD
